◀ HEALTH & SAFETY ALERT ▶

Overturned Dumper

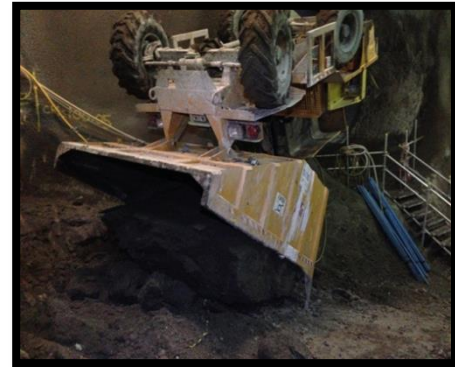
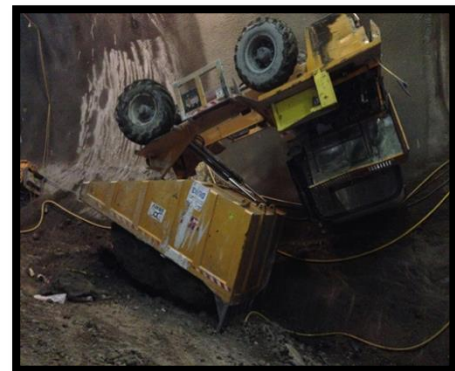
A 10 tonne Dumec dumper was moving a load of shotcrete in C510, Finsbury Circus tunnel, to a stockpile area. The area was on an incline and when the dumper truck discharged the load down the incline, the truck's centre of gravity moved, resulting in the truck overturning and landing on its roof.

The IP suffered a laceration that required stitches and bruising to his chest. The injuries sustained were minimised due to the fact that the operator was wearing his seatbelt.

- The shotcrete had solidified, causing the whole load to move at once
- Low tyre pressure
- Dumper operating outside of the manufacturer's guidance with regards working on gradients

- Never discharge a load facing forward on an incline
- Thorough plant checks and tag completion must be carried out
- You must work to manufacturers recommendations
- Wear seat belts at all times when operating plant
