HSE Alert 10 in 2019

Defective Lucy service cut outs

Date of issue: 30 September 2019

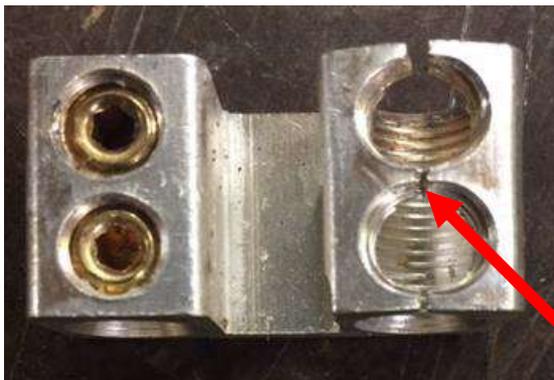
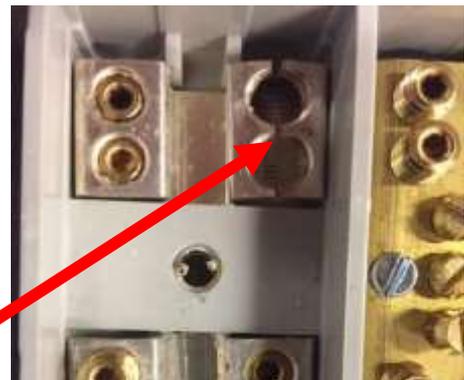
They found that the terminal block 'split' as the screws were being tightened using an insulated 3mm allen key. The 'split' terminal block can be seen in the images below.

'Splitting' in the phase terminal block

NIE Networks tested other units at their training centre and found that these Lucy units also 'split' on the phase terminal block.

If the cables are not secured they could become loose and expose live conductors which could result in electric shock. They can also get hot which could result in a fire and if connections become intermittent this could result in damage to downstream equipment.

1. Before starting any work involving alterations/amendments to Lucy service cut outs, the terminal blocks should be inspected for any 'splits'.
2. During any work on Lucy service cut outs, care should be taken when tightening screws in the terminal blocks and once work on the cut out has been completed terminal blocks should be inspected for any 'splits'.
3. Any defective cut outs should be returned to Lucy via your supplier for a replacement or where it is not a TfL asset, the asset owner notified.

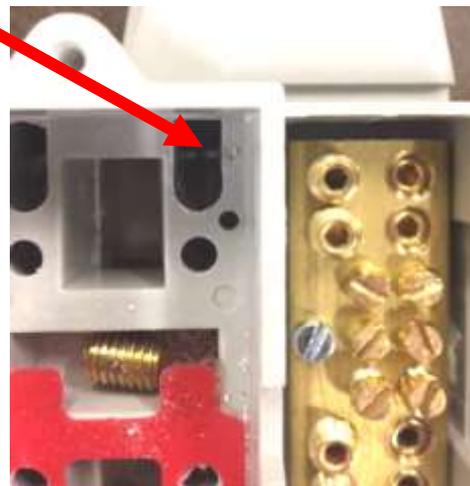
Lucy house cut outs known to be affected:

- 100 A single pole fuse unit with separate neutral and earth terminals & PME link
- 100 A single pole fuse unit with combined neutral and earth terminals for PME systems
- 100 A single pole fuse unit with separate neutral and earth terminals & PME link with two type 'B' cut outs (fuses)
- 100 A single pole fuse unit
