**Item 6: Structures and Tunnels Investment Portfolio – Managing Safety Risks**

## Appendix 1: STIP Structures

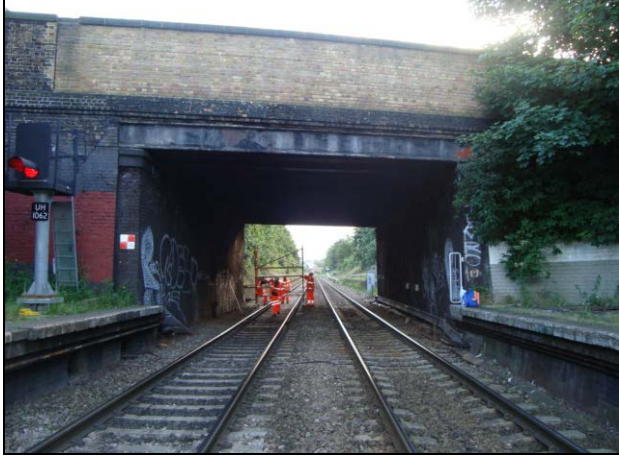
Structure Name	Description and planned works
<p data-bbox="172 264 507 297">1. Upper Holloway Bridge</p>

<p data-bbox="849 264 1473 573">A road-over-rail single span bridge built circa 1868. It carries the A1 Holloway Road, comprising two traffic lanes and two bus lanes, over a section of the London Overground. The bridge is adjacent to Upper Holloway Station. The structure has deteriorated rapidly in the last 10 years and cannot be economically repaired. A full replacement is required to avoid future restrictions and closures.</p>
<p data-bbox="172 779 405 813">2. Ardleigh Green</p>

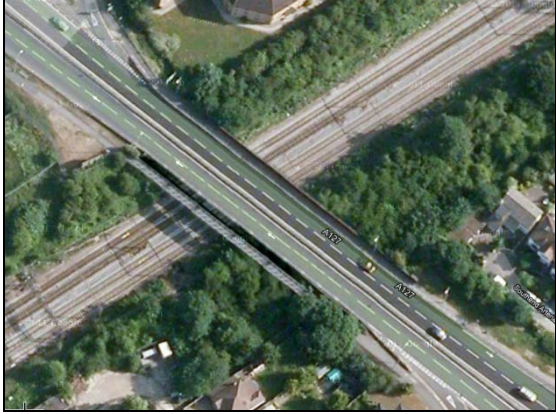
<p data-bbox="849 779 1473 1077">A road-over-rail three span bridge carrying the four lanes of the A127 over busy railway lines. The bridge deck is riveted steel beams and concrete jack arches. The abutments are mass brickwork and the intermediate supports are riveted steel trestles. A footway, integral to the bridge, is on the east side and a separate footbridge provides pedestrian access on the west side.</p> <p data-bbox="849 1088 1299 1122">The whole bridge will be replaced.</p>

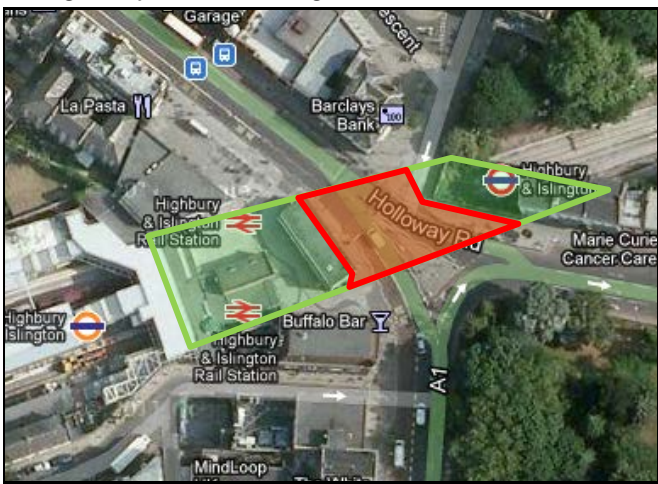
<p data-bbox="172 1249 515 1283">3. Highbury Corner Bridge</p>

<p data-bbox="849 1249 1473 1547">A road-over-rail bridge constructed circa 1930, it crosses the London Overground railway, supports the highway, and hosts commercial and residential buildings. The section of the bridge supporting the A1 highway, approx. 40m x 23m, is owned and managed by TfL, highlighted opposite in red. This section is in a poor state of repair and vehicles carrying heavy loads are restricted.</p> <p data-bbox="849 1559 1313 1626">The planned works are a full bridge replacement.</p>

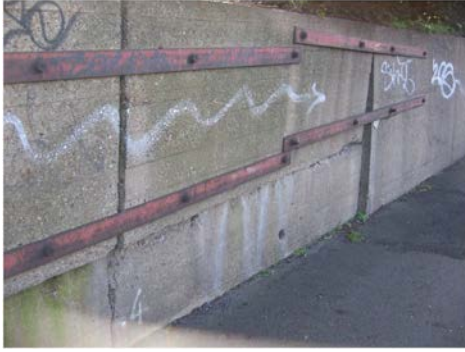
#### 4. A406 Woodlands Retaining Wall

The wall is located east of the Brent Cross interchange, on the south side of the A406 North Circular Road. It retains the gardens of properties backing onto the A406. It is approximately 200m long and made up of 55 mass concrete panels of differing lengths and heights. There are a number of services running in the vicinity of the wall, including gas and electricity.

Temporary propping has been installed to prevent collapse in the short term. The whole wall will be replaced.

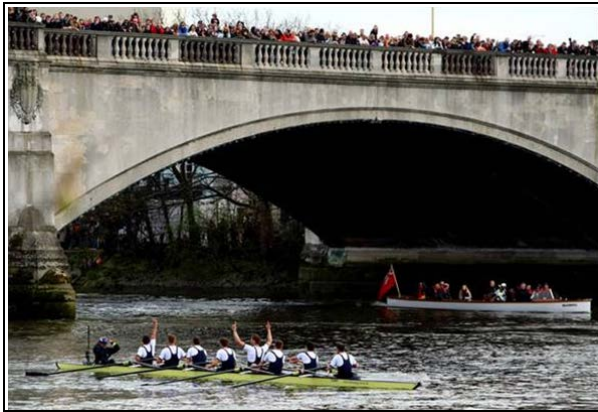
#### 5. Chiswick Bridge

Constructed in 1933, it is a five span reinforced concrete arch bridge carrying the A316 over the River Thames. It is Grade II\* listed and suffering from deterioration of the deck, supports and parapets. The previous capacity assessment (in 1999) indicated minimal reserve, meaning restrictions may be necessary if further deterioration occurred (which is now the case).

A major refurbishment of the bridge is planned.

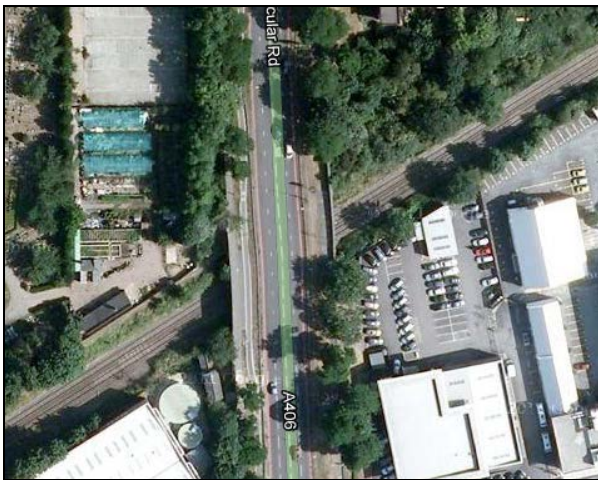
#### 6. Power Road Rail Bridge

A three span road-over-rail bridge built circa 1922. It carries the A406 North Circular Road (Gunnersbury Avenue) over two Network Rail lines, shown opposite.

The construction form is a reinforced concrete beam and slab deck supported on reinforced concrete abutments and piers. The deck is in a very poor condition and will be replaced.

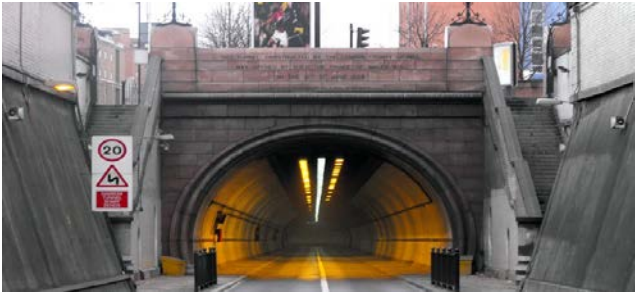
Structure Name	Description and planned works
<p><b>1. A101 Rotherhithe Tunnel</b></p>

<p>A single bore, bi-directional tunnel, approximately 1125m long, carrying the A101 and a pedestrian footway under the River Thames. The structure comprises cast iron segments faced with mass concrete and decorative tiles. The structure was constructed c1908 and parts of it are Grade II listed.</p> <p>Planned works include replacing fire mains, replacing flood gates, renewing pump stations, upgrading detection systems and ventilation, upgrading lighting to LEDs and structural repairs.</p>
<p><b>2. A12 George Green Tunnel</b></p>

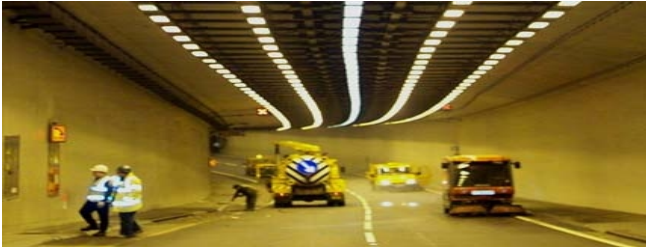
<p>A 295m long twin cell, cut and cover structure constructed from secant piles and a reinforced concrete top and bottom slabs. Each bore carries a two lane carriageway. The structure was built c1999.</p> <p>Planned works include upgrading lighting to LEDs, installing detection systems and wayfinding signs, and renewing safety systems and equipment.</p>

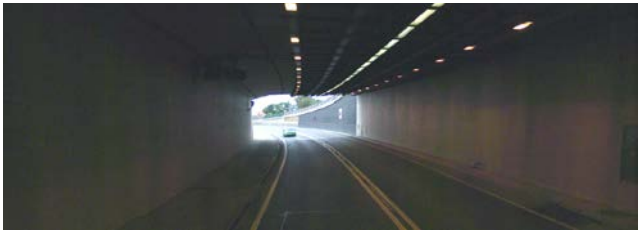
<p><u>3. A12 Green Man Tunnel</u></p>

<p>A 297m long twin cell, cut and cover structure constructed from secant piles and a reinforced concrete top and bottom slabs. Each bore carries a two lane carriageway. The structure was built c1998.</p> <p>Planned works include upgrading lighting to LEDs, installing detection systems and wayfinding signs, and renewing safety systems and equipment.</p>
<p><u>4. A102 Blackwall Tunnel Southbound</u></p>

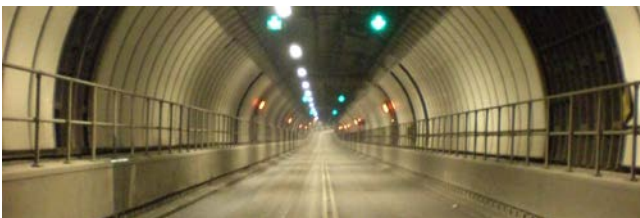
<p>A single bore, single directional tunnel, approximately 1174m long, carrying the A102 under the River Thames. The structure predominantly comprises cast iron segments with reinforced concrete sections towards either end. The structure was constructed c1967.</p> <p>Planned works include upgrading the ventilation system, upgrading emergency access/egress, upgrading and renewing the tunnel safety and operational systems.</p>
<p><u>5. Hogarth Flyover Deck Replacement</u></p>

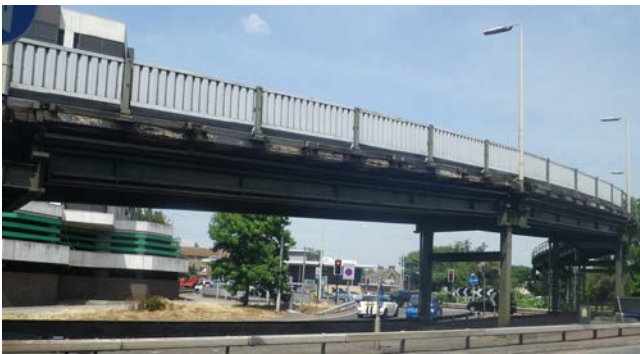
<p>IAR Gate 4 and Project Authority Submission approved at SAB on 06/0514.</p> <p>The planned works are a full deck replacement</p>

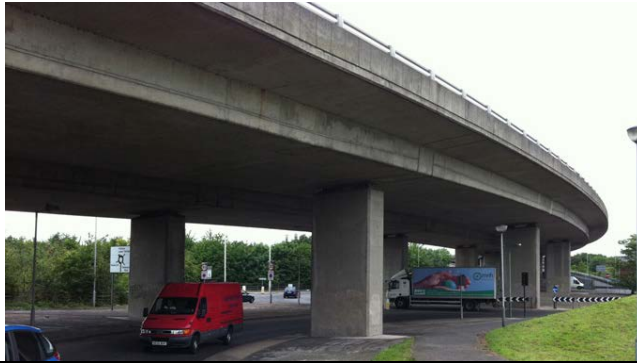
7. A316 Country Way Viaduct

A 23 span continuous reinforced concrete box girder bridge deck supported by reinforced concrete columns and abutments. The structure was built c1975.

Planned works include replacing expansion joints, repairing post-tensioning, repairing the drainage system and concrete repairs.

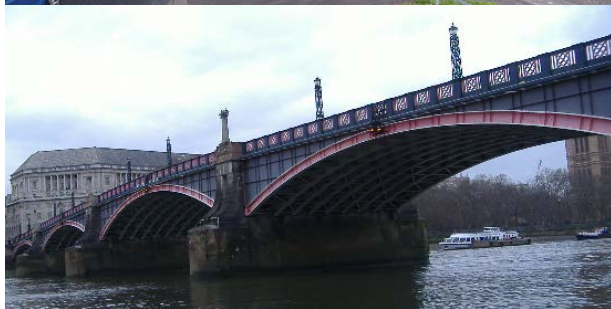
8. A3203 Lambeth Bridge Refurbishment

A five span bridge carrying the A3202 and two footways across the River Thames in central London. The deck comprises steel arch girders and concrete slab supported by concrete piers clad with granite. There are ornamental balustrades and lamp columns in cast iron and ornamental granite obelisks on the approaches. The structure was constructed c1932 and is Grade II listed.

Planned works include replacing corroded steelwork, repainting, waterproofing and renewal of joints and bearings.

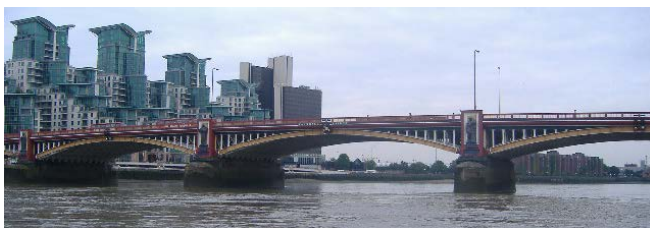
9. A202 Vauxhall Bridge Refurbishment

A five span bridge carrying the A202 and two footways over the River Thames. The deck comprises steel arch girders with a steel plate and concrete slab supported by granite faced concrete piers and abutments. The structure was constructed c1906 and is Grade II\* listed.

Planned works include replacing corroded steelwork, repainting, waterproofing and renewal of joints and bearings.

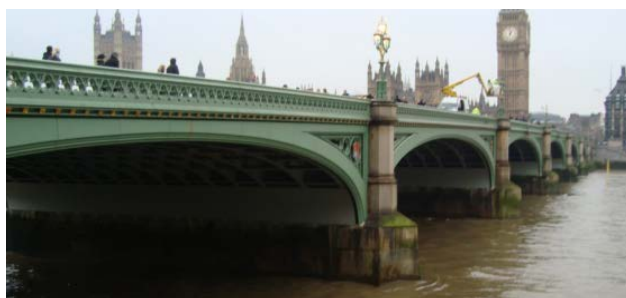
10. A302 Westminster Bridge Painting

A seven span bridge carrying the A302 and two footways over the River Thames. The deck comprises wrought iron arched girders and concrete deck slab. Previous major maintenance has included strengthening of the deck, scour protection to the piers and replacement of the cast iron fascias. The structure was constructed c1862 and is Grade II\* listed.

Planned works included repainting and refurbishment of the deck drainage system.

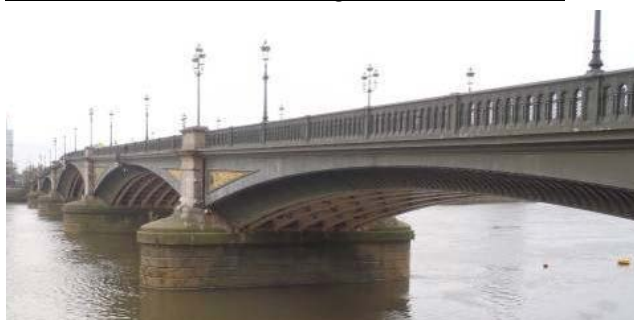
11. A3220 Battersea Bridge Refurbishment

A five span bridge carrying the A3220 and two footways over the River Thames. The bridge deck is of wrought iron, cast iron and concrete construction supported by granite and brickwork piers. The bridge was constructed c1890 and is Grade II listed.

Planned works include replacing corroded steelwork, repainting, waterproofing and renewal of joints and bearings.

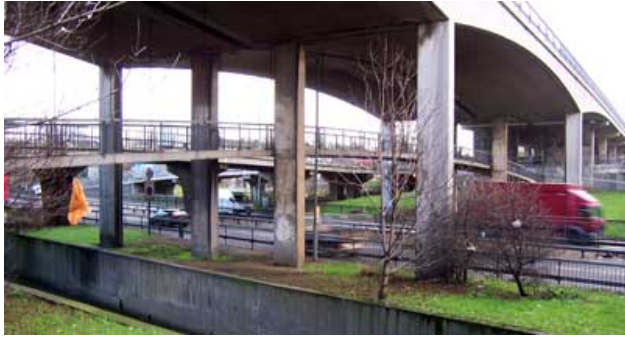
### 12. A406/A41 Brent Cross Structures

The A406/A41 Brent Cross interchange is made up of approximately 18 structures. The structures are all concrete in construction and were built c1965.

Planned works include waterproofing, parapet upgrades, bearing and expansion joint replacement and concrete repairs, and improvements to headroom and alignment all in conjunction with the major development of the shopping centre.

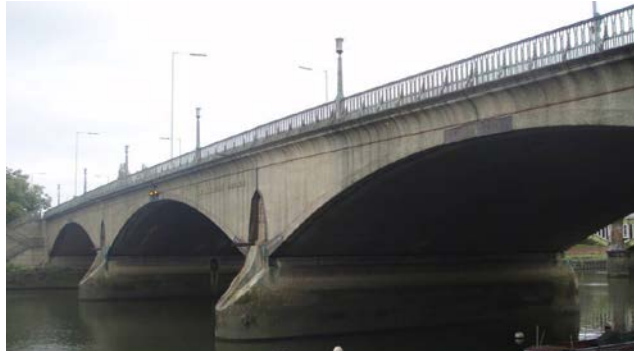
### 13. A316 Twickenham Bridge Refurbishment

A five span concrete arch deck supporting internal columns and a concrete deck slab. Ornamental brass railings are provided to the deck edges and staircases. The structure was constructed c1933 and is Grade II\* listed.

Planned works include concrete repairs (arches, abutments and approaches), replace waterproofing and renewal of joints and bearings.
