LONDON UNDERGROUND LIMITED

SAFETY BULLETIN

Failed London Overground Roundel Sign

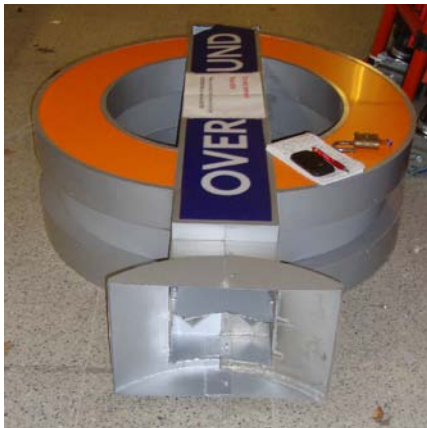
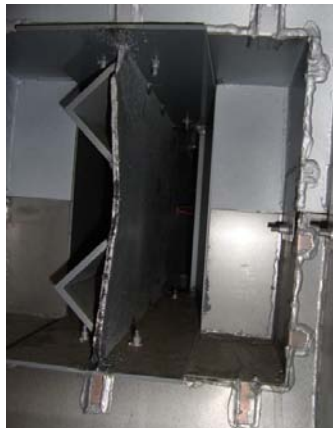
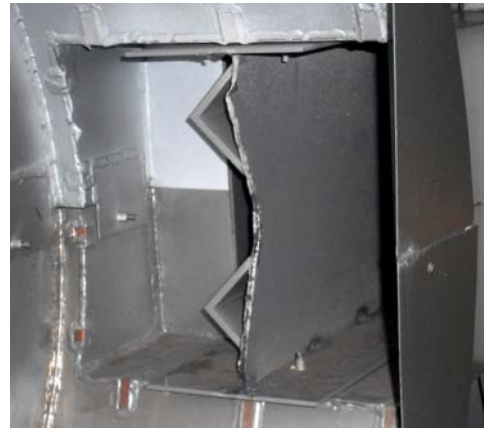
On 31 December 2012 a cantilevered roundel sign at the southern entrance/exit to Dalston Junction station, originally manufactured by Signscope Limited in approximately 2010, fell off the station wall onto the public area below. No-one was hurt and investigations are underway into the cause of the failure. Initial investigations indicate that the design of the sign itself could be to blame. All similar signs manufactured by Signscope have been inspected for indications of damage and removed if necessary. Those parts of TFL known to have signs from the same batch have been contacted.

Action has already been taken by Tube Lines to remove the roundel signs from the same manufacturer and batch installed at Kingsbury Station. APD have confirmed they do not have any similar roundel signs from the same manufacturer installed on the network.

This incident serves as a reminder that all signs and their associated fixings should be specified, designed and correctly installed by competent persons who have an adequate understanding of structural behaviour. All works to LU stations should comply with the relevant Cat 1 Standards. Advice can be sought from LU Building Control on SMBBuildingControlAp@tfl.gov.uk
