**Bulletin(Ref.:26in2013)**

**Work on or adjacent to utilities and High Voltage cables**

Date of issue: 23 December 2013  
 Date of review: 23 June 2014

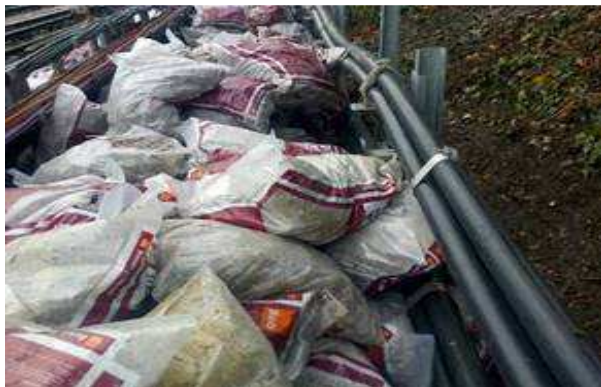
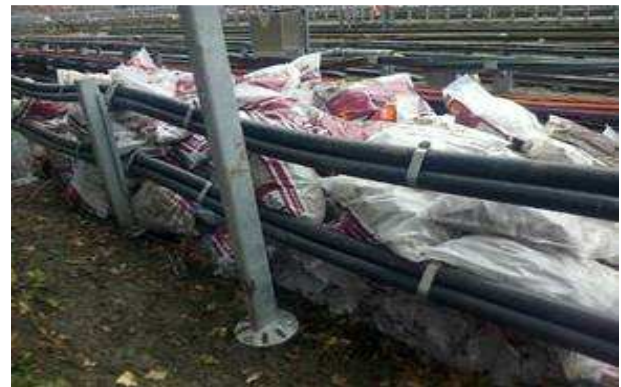
A recent LU inspection identified that approximately five tonnes of bagged ballast had been wedged between cable runs 150m south of bridge MR32, adjacent to the Wembley Park southbound tracks.

This incorrect storage of materials resulted in heavy bags resting against live high voltage 22KV electrical cables, which could have caused significant harm to workers and damage to the cables.

When work is to be undertaken adjacent to any power cables, on railway structures or in the track formation which may contain cables, the Safe System of Work (SSoW) must comply with S1114 'Safe Systems of Work on or Near Electrical Equipment'.

The SSoW must address:

- potential hazard to persons arising from the presence of cables and
- potential damage to cables resulting from adjacent work activities.
