Rapid Pothole Repair System Trial (Road Mole)

TfL Lane Rental Industry Publication

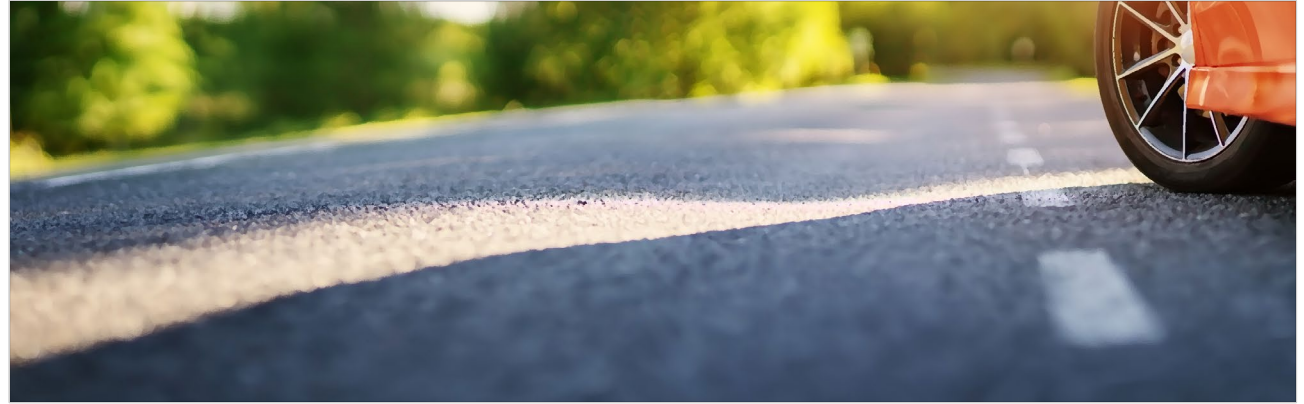
The repairs were found to be completed within a quicker timeframe than those of traditional method.

Noise levels were recorded at much lower levels than those recorded during the use of pneumatics. On this basis, it was determined that Road Mole could increase the ability to carry out night-time carriageway repairs where they are situated in more densely populated areas.

A circular repair was also deemed more economical insofar as the amount of material excavated/replaced compared to the usual square/rectangular shape.

Early indications highlight the repairs are performing to required standards with no signs of failure.
